# WILD FIGHELDEAN PROJECT

WESSEX RIVERS TRUST,  
ENVIRONMENT AGENCY,  
NATURAL ENGLAND

# Introducing the ‘Wild Figheldean’ project

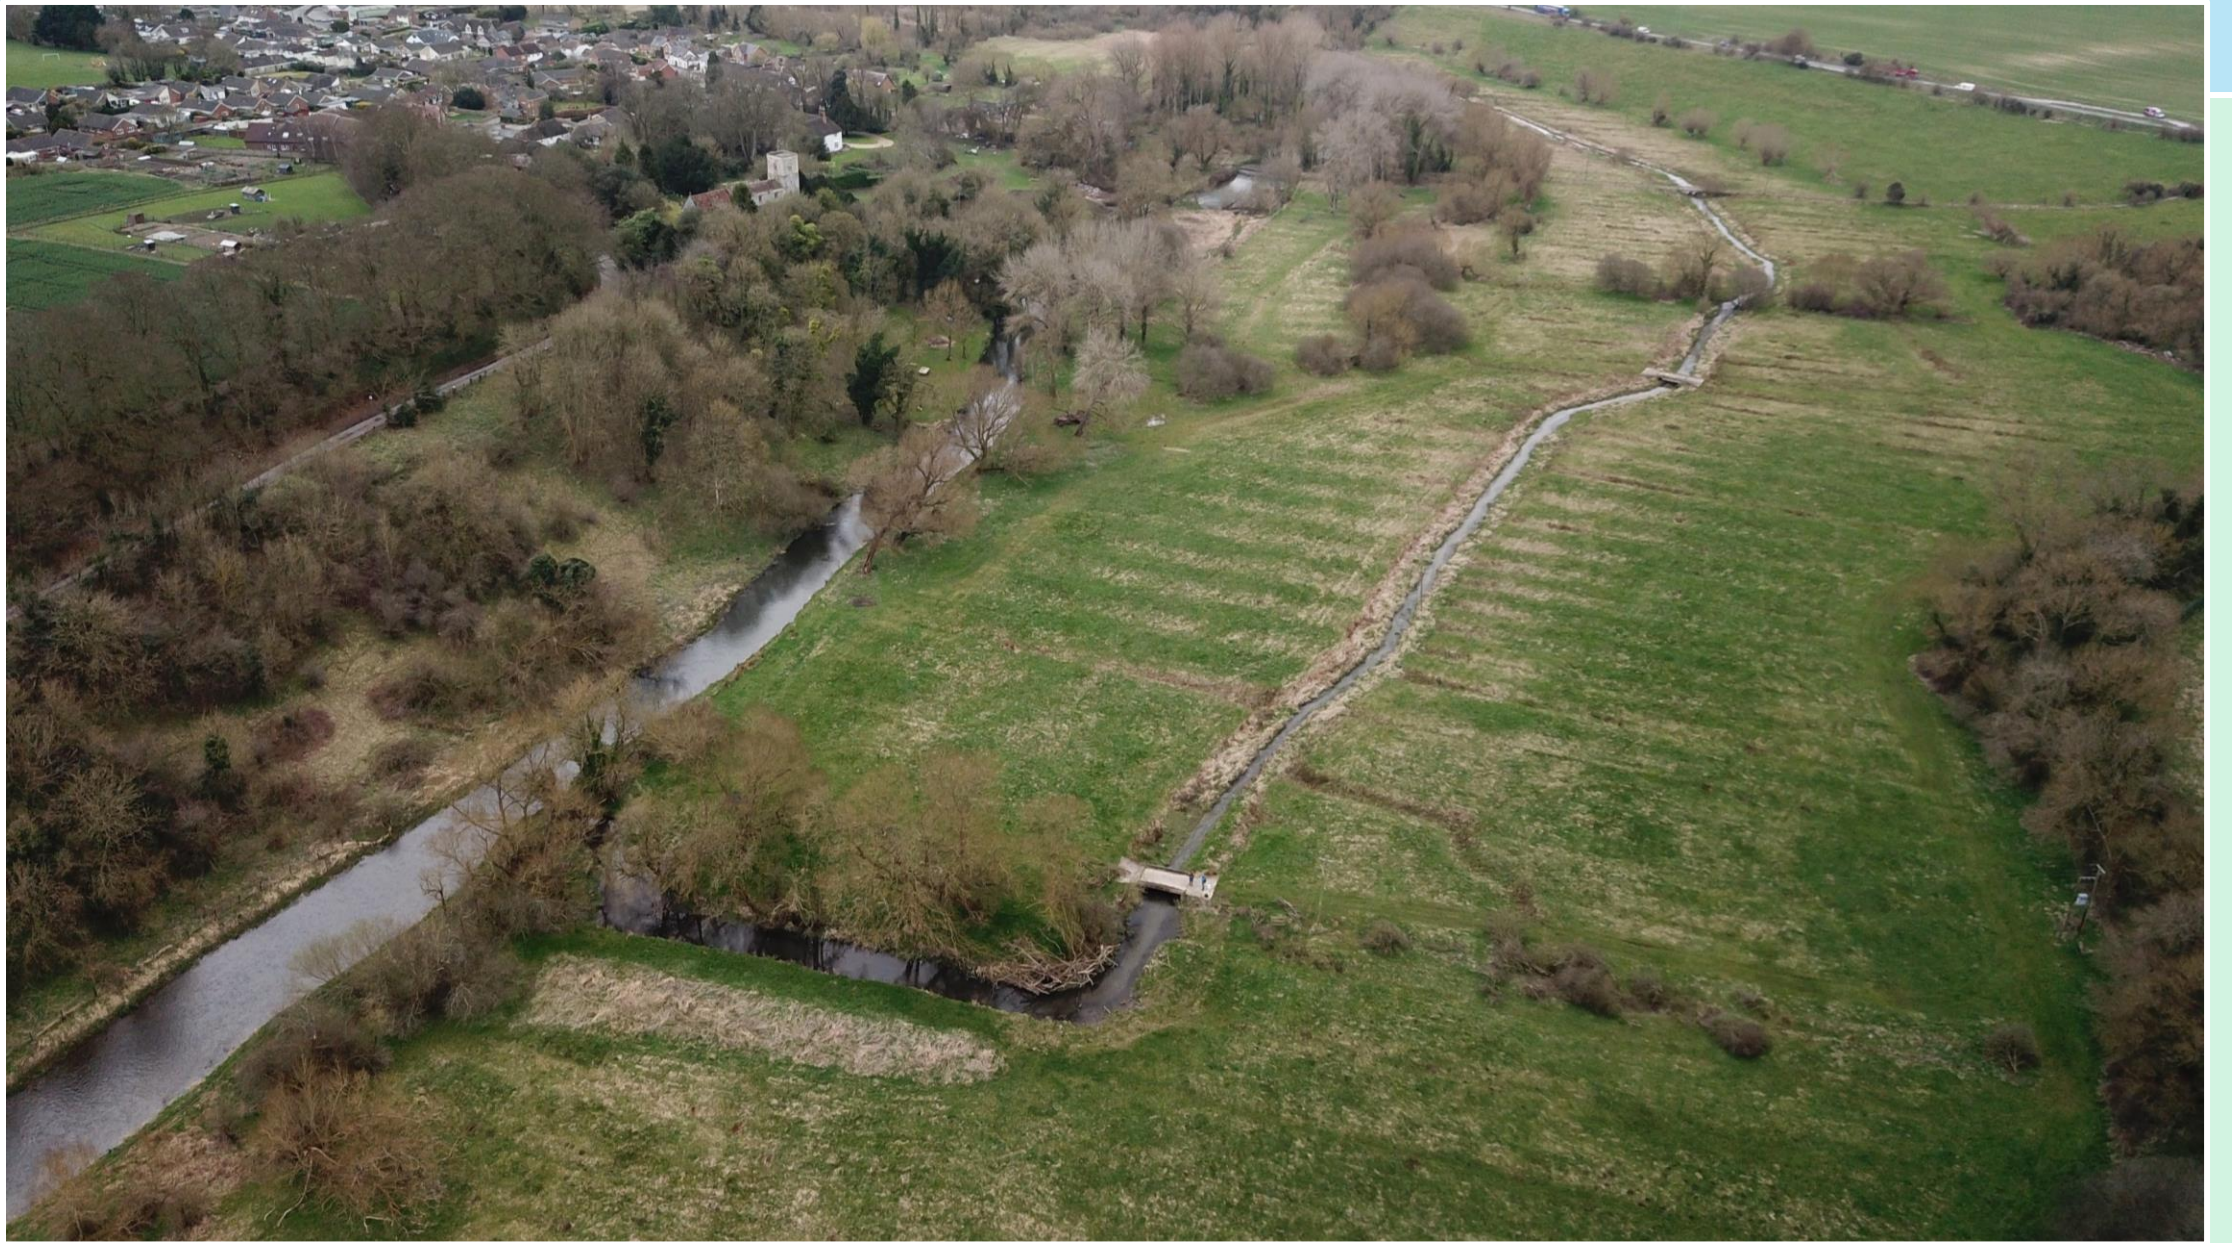
# The River Avon at Figheldean – a slice of history

- Long history of management
  - First mention of a mill on the river is in the 1086 doomsday book, not necessarily in the position we know.
  - River re-aligned (moved to the edge of the valley to feed the mill)
  - River was managed for multiple purposes – evidenced by the meadow showing the previous water management techniques
  - Historic channel management. Existing channel always had a bypass channel where the gabion baskets are. This would have been the primary channel to avoid flooding to the mill.
-

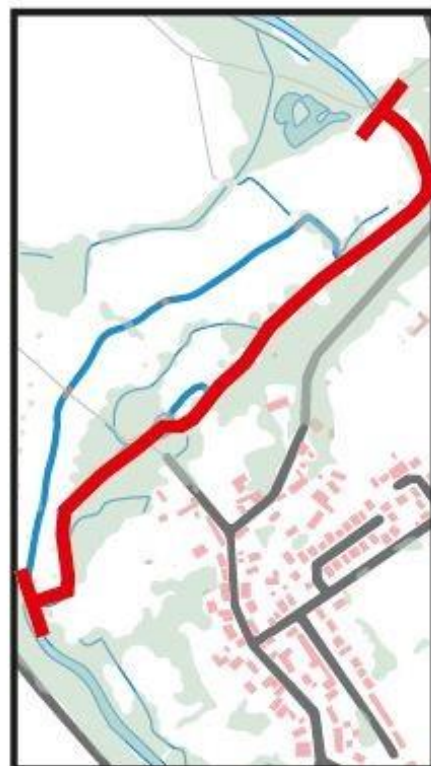
Drawing No.

# River Avon Main channel long section

Length: 967.14 m

Fall: 1.32 m

**Gradient: 1:732**

weir

weir pool

- Impounded by the weir
- Gradient drops out
- Sediment build up behind weir
- In-stream gravels become clogged
- Fish passage issue

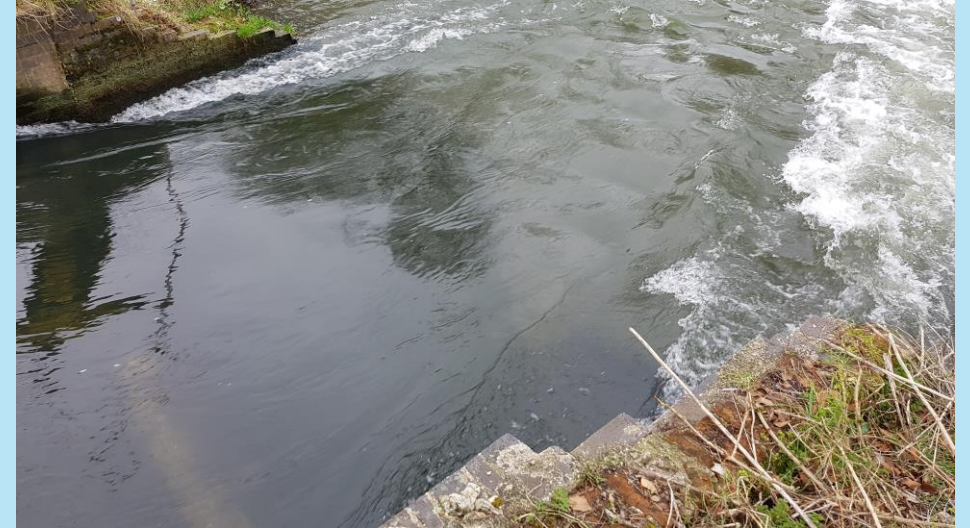
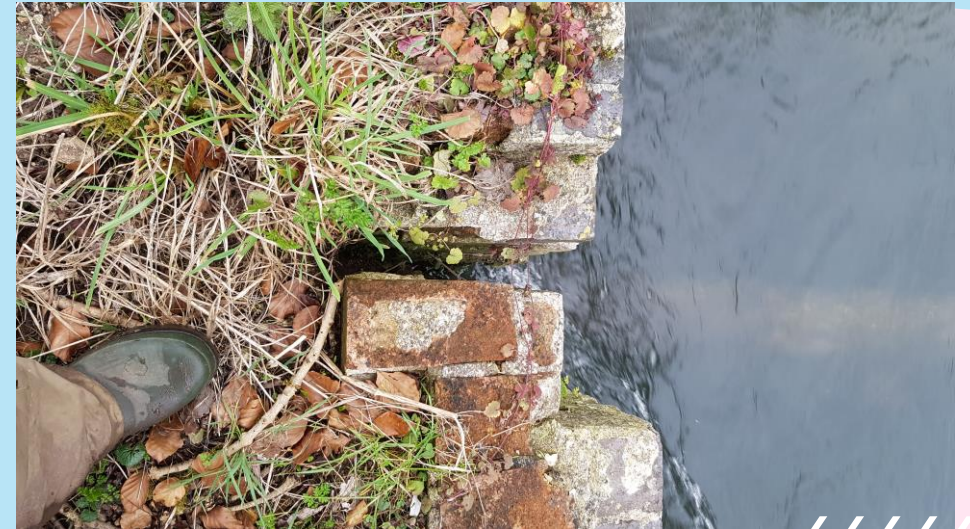
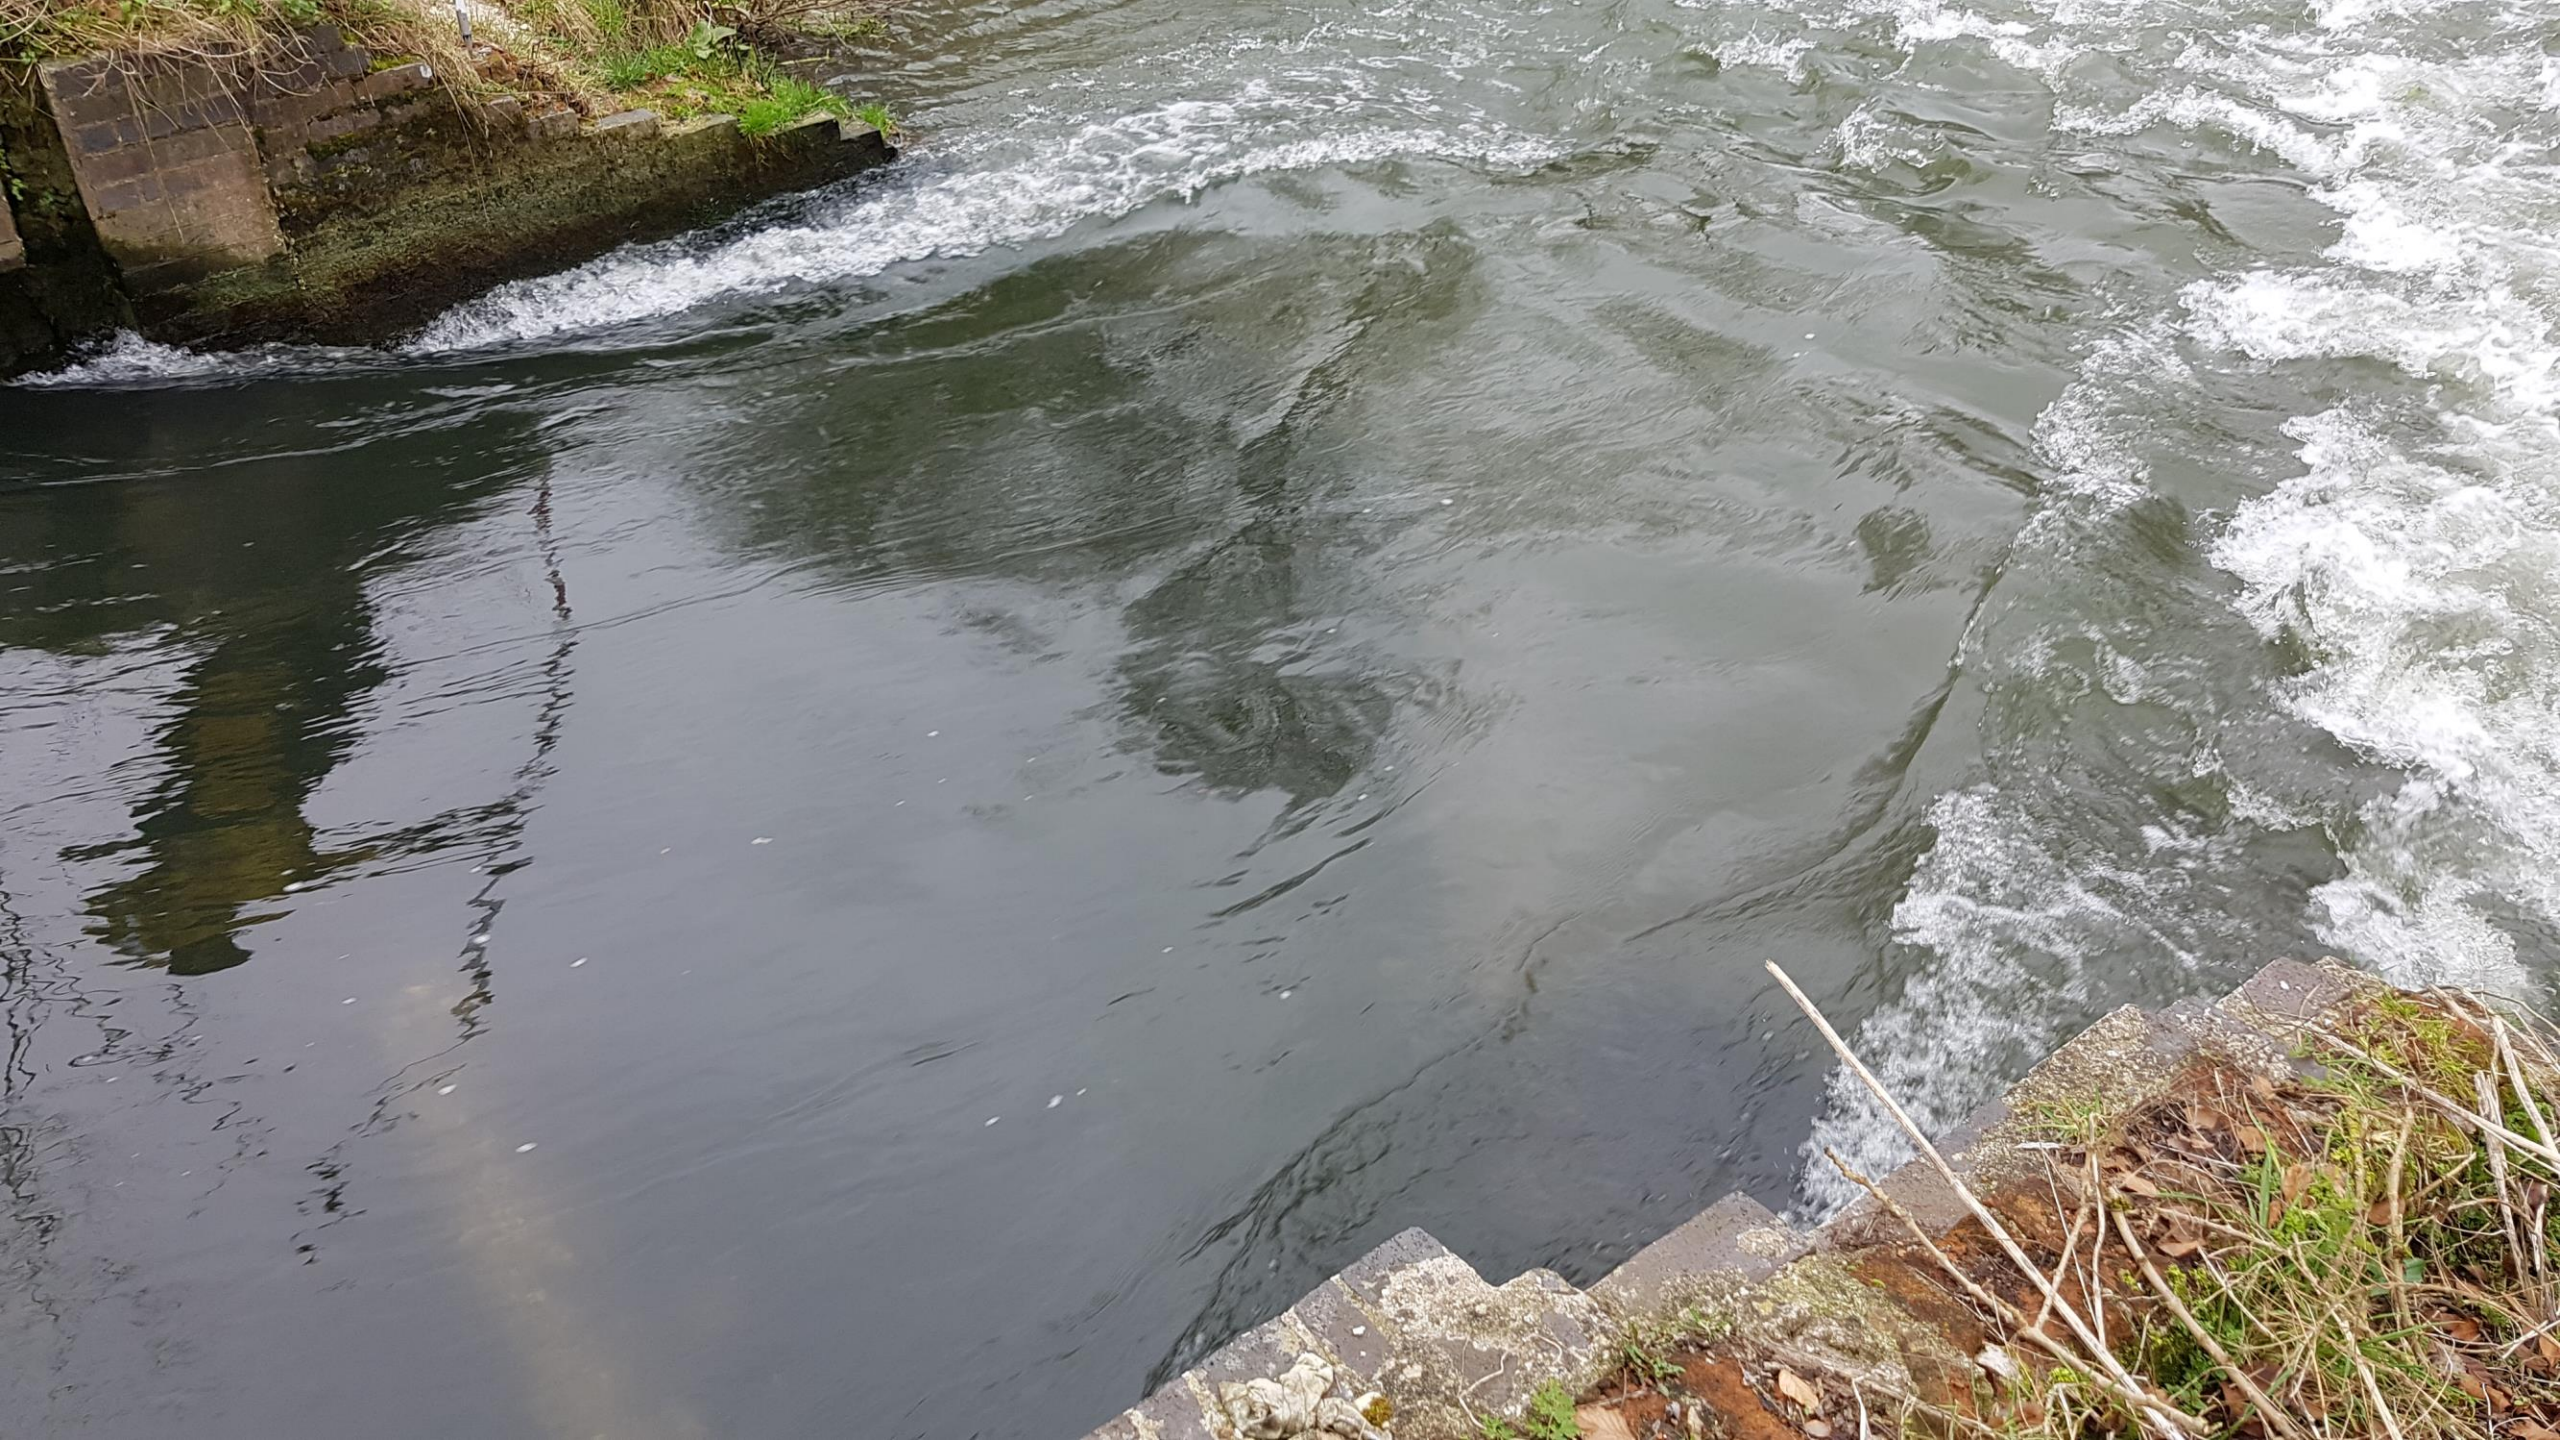
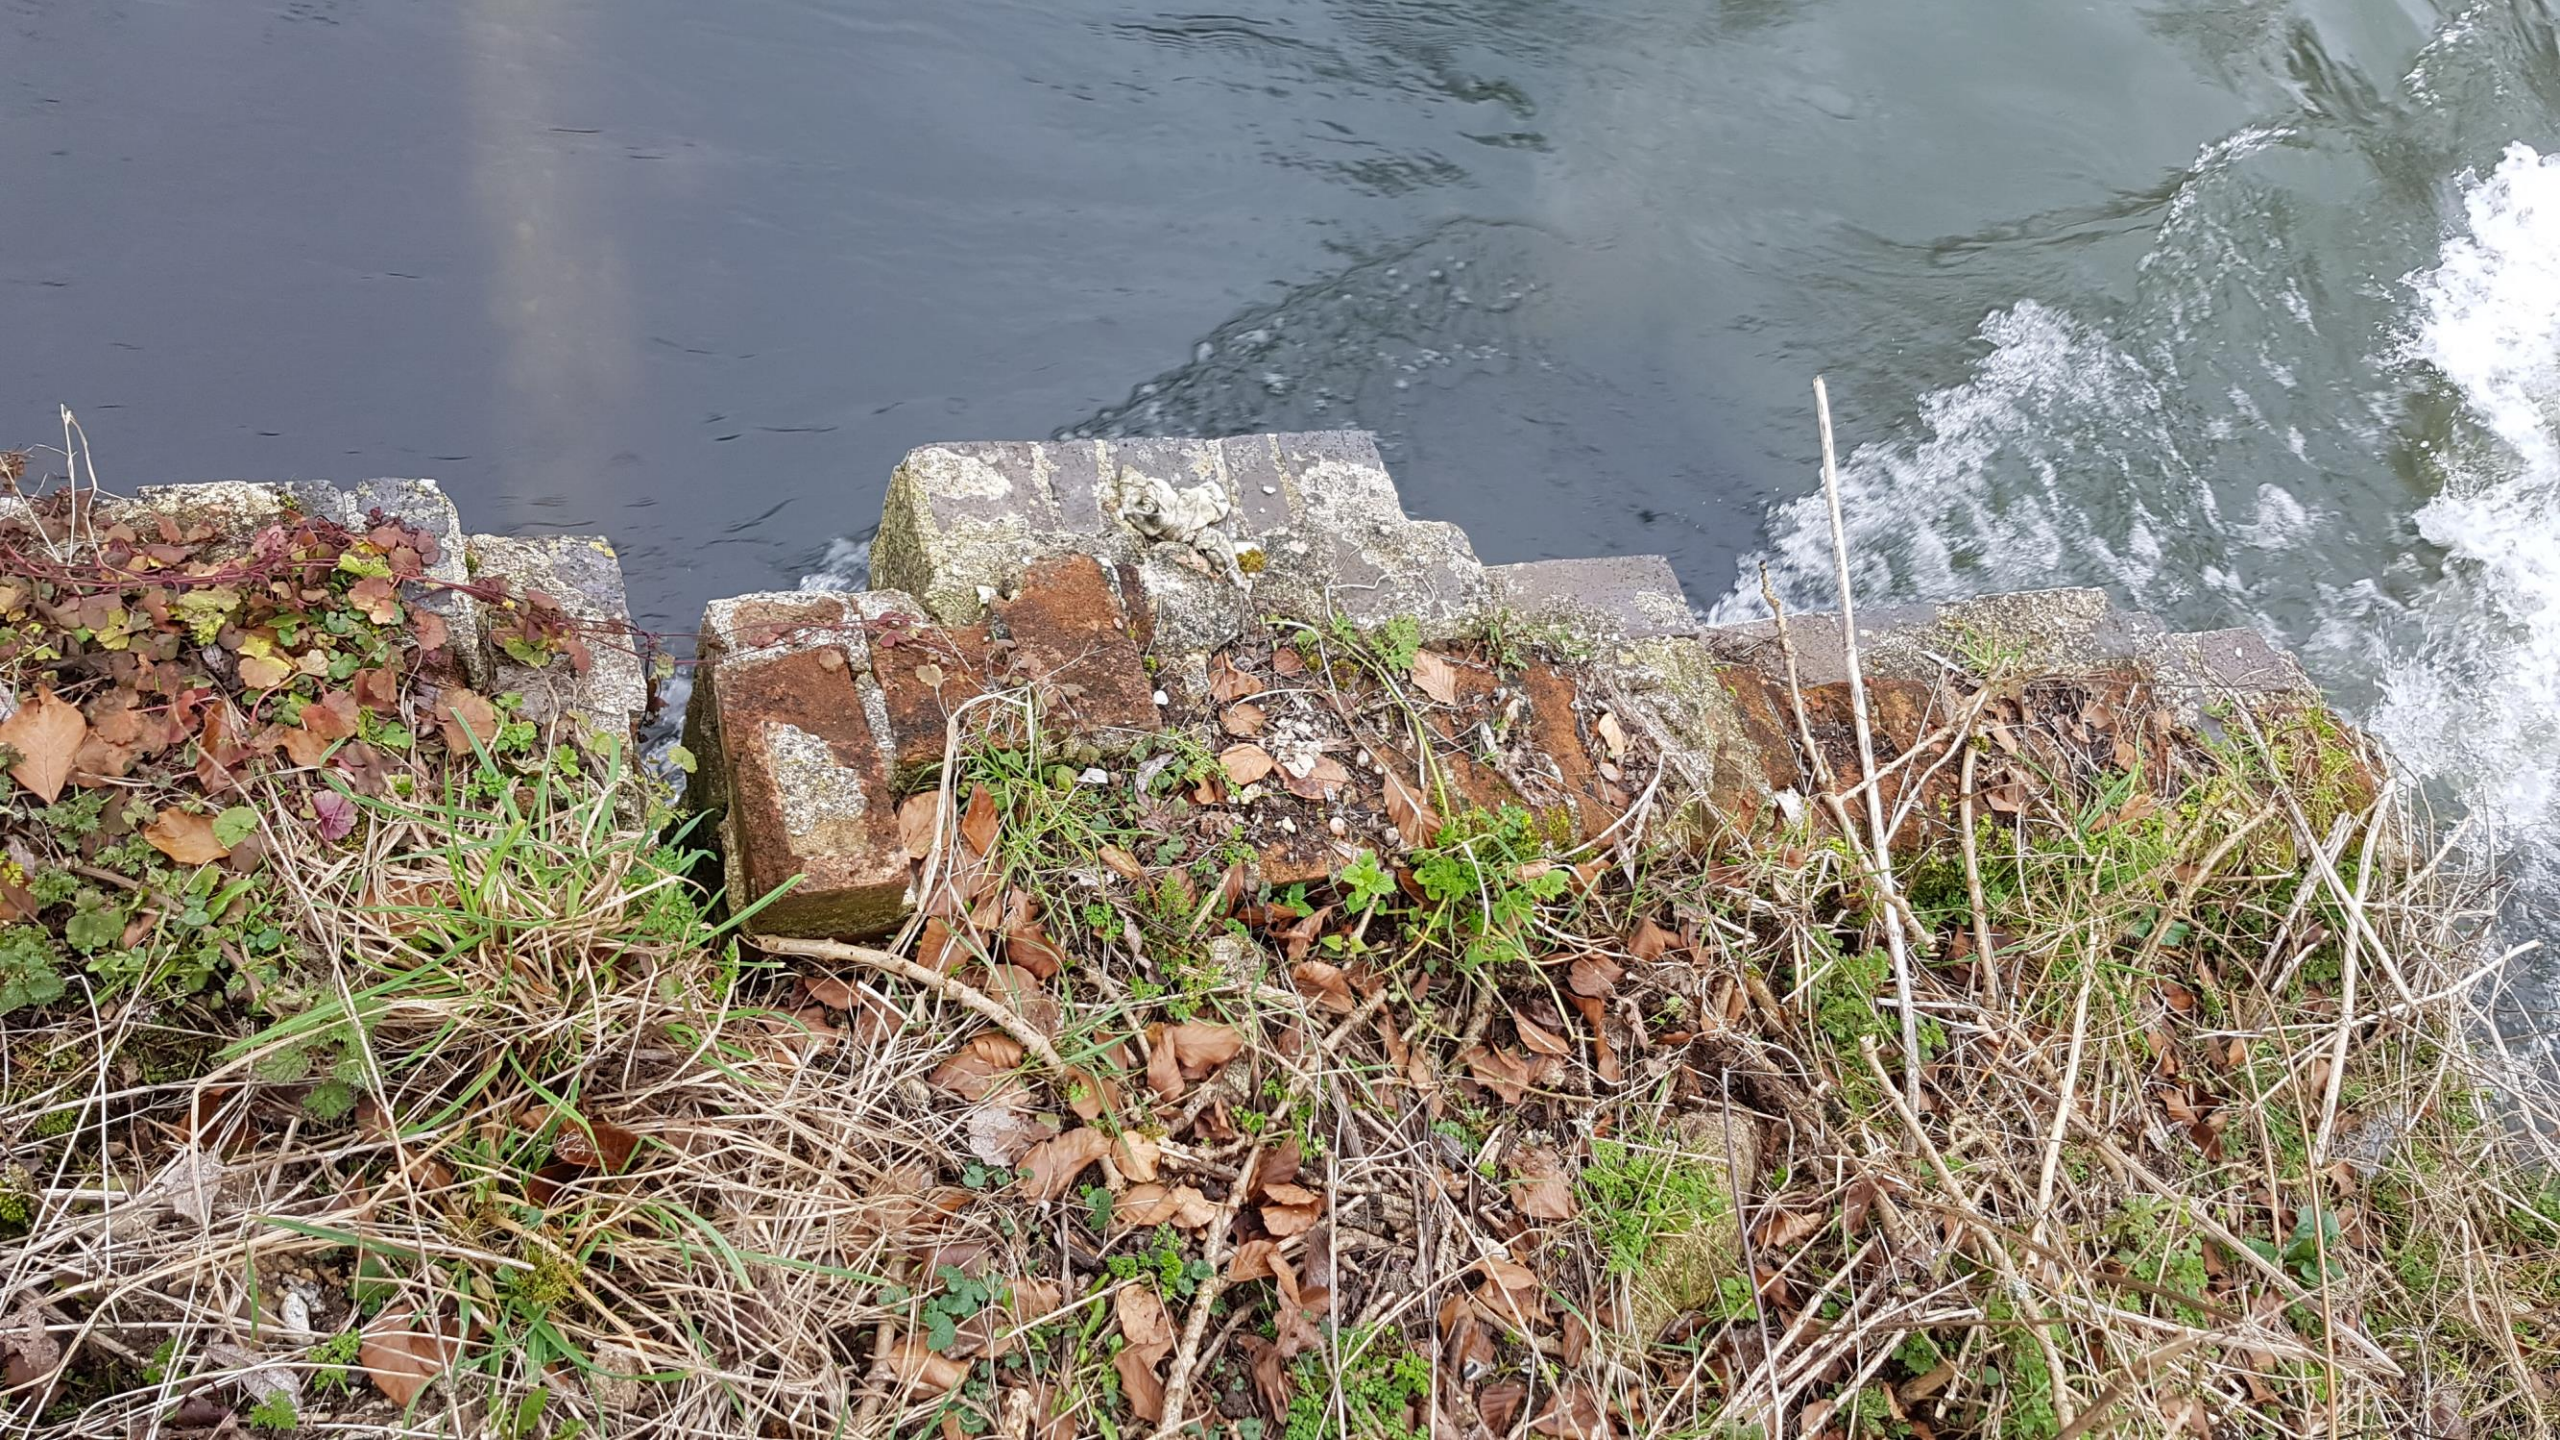
- Weir sill is in a state of disrepair
- Wing walls are failing
- Structure is in danger of collapse
- Attractive but dangerous swimming - weir pool
