Water Vole & Otter Survey Report

Figcheldean

River Avon, Wiltshire

28 March 2022

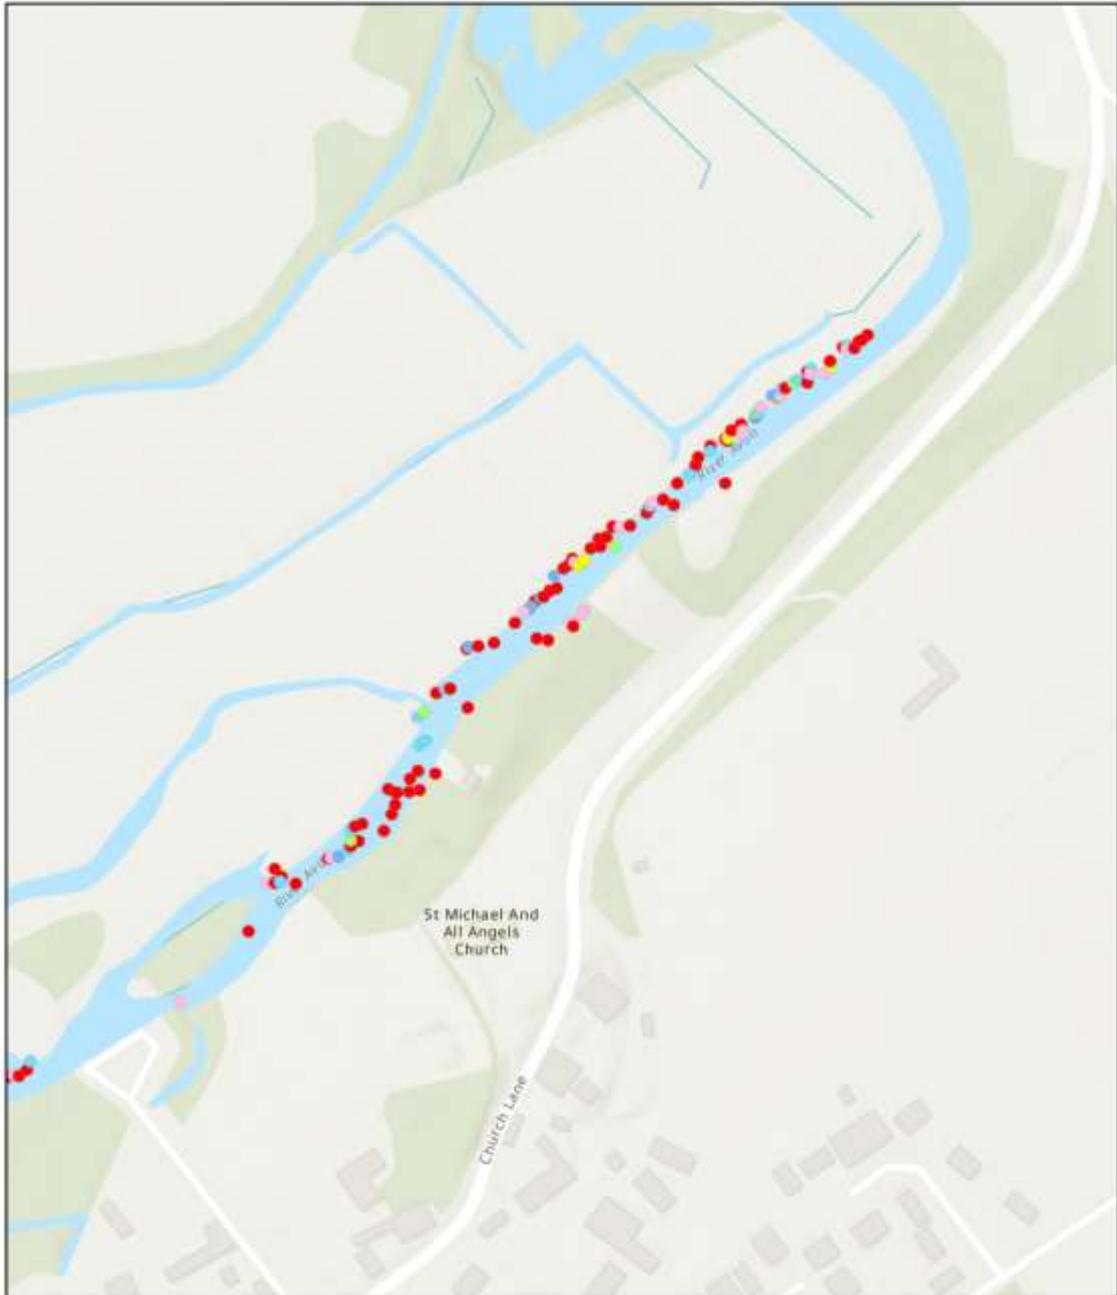
# Figheidean River Restoration - upstream water vole survey spring 2022

Evidence of water vole activity in the form of active burrows (90), latrines (20), feeding remains (7), droppings prints and runs was recorded within the site boundary. 20 latrine sites were observed during the survey, equating to 4 latrines per 100m of channel. This classifies the site as a 'medium' relative population density using the methodology devised by Dean et al., 2016. Based upon surveyor experience, it is determined that latrine abundance was likely under-recorded (see 2.3 limitations) and that there is a probable 'high' relative population density based upon abundance of other field signs, particularly considering the early season survey timing.

The survey reveals a significantly higher abundance of water vole activity, particularly burrowing, on the true right bank of the main channel than the true left bank. It is likely that burrow abundance is influenced by bank profile and composition, with the high steep faced clay-rich true right bank providing better burrowing opportunity. The true left bank has a gentler sloping profile and is heavily vegetated by emergent macrophytes. Whilst potentially less suited for burrowing, survey records indicate that the bank may be an important foraging resource.

Some spatial variation in habitat suitability is demonstrated across the site. Lengths of 'hard' artificial bank e.g. gabion baskets and aggregate combined with higher levels of riparian shade immediately upstream and downstream of the main weir provide lower quality burrowing and foraging habitat and this is reflected in a slightly reduced abundance of water vole activity in this reach.

- Risks should be designed-out within detailed designs/method statements to avoid or minimise significant impact upon the species. Grading of banks or installation of hard (i.e. aggregate) bankside structures i.e. aggregate berms must be located to avoid disturbance of active water vole burrows. Use of soft (i.e. woody) structures may be more appropriate to avoid/minimise impacts in those locations. Suitable open water habitat should be retained in the locality of active water vole burrows.

- A full repeat water vole survey should be undertaken in the second half of the survey season (July-September) to provide a full assessment of water vole activity within the site.

- A repeat check for water vole activity by a experienced surveyor should be undertaken in the location of works that may cause physical disturbance of the river bank or marginal vegetation immediately prior to works. Similarly, any plant tracking route to reach the channel must be inspected to ensure 5m avoidance of vole burrows where practicable. Precautions such as ground protective track matting should be utilised where appropriate.

- Active water vole burrows must be identified and clearly marked-out on site immediately prior to commencement of works to ensure a safe working distance (5m where feasible) is retained.

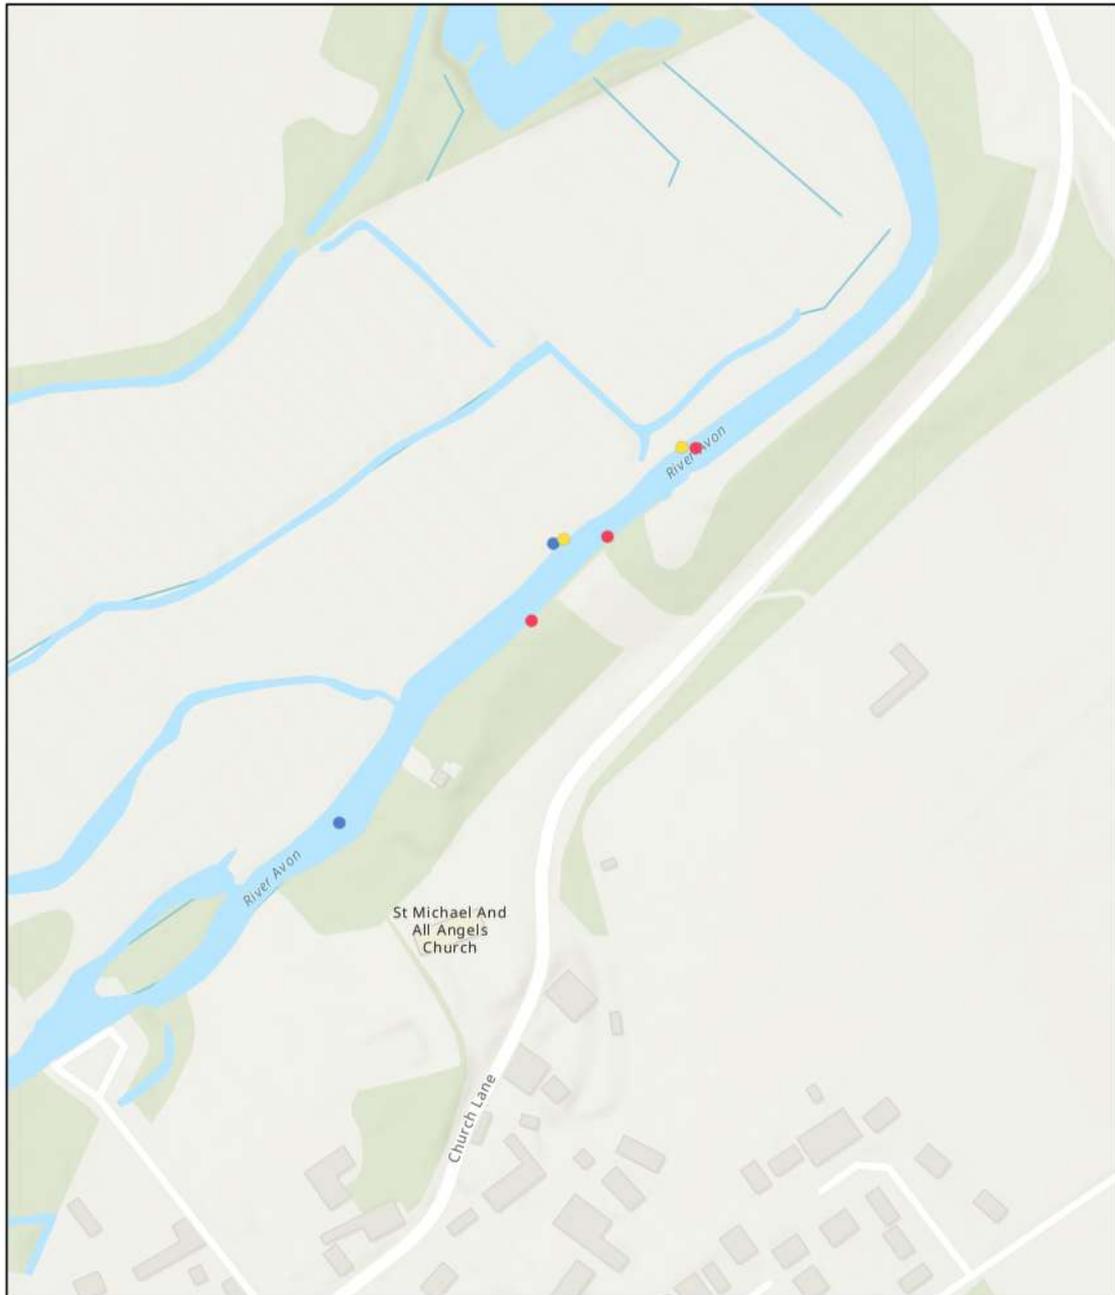
## Figheldean River Restoration - upstream otter survey spring 2022

Extensive evidence of Eurasian Otter was recorded within the extent of the survey. Records comprised spraints (4), slides (3) and prints (3). The abundance and clarity of signs indicates recent use of the site by otter. No evidence of holts or couches/lay-ups were recorded during the survey.

Based upon the survey records, it is considered highly likely that otter utilise the site for foraging and migration. The reach upstream of the reach offers excellent foraging opportunity, with limited in-channel habitat complexity and an abundance of stocked fish.

- Risks should be designed-out within detailed designs/method statements to avoid or minimise significant impact upon the species. Damage or disturbance of the bankside and riparian areas should be minimised where possible as to minimise impact on foraging habitat.
- Prevention of any temporary barriers that may impede continued access throughout the site to facilitate upstream/downstream otter migration during the works.
